# **Educational Facilities and Risk Management**

**Natural disasters**

## **Risk Assessment and Strengthening Educational Facilities Against Natural Hazards**

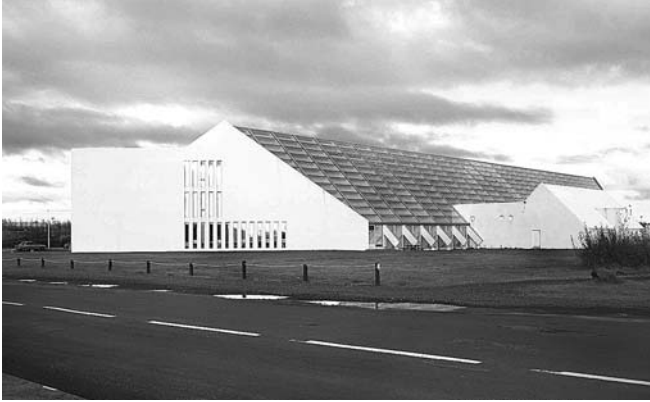
Figure 2. **Modern school building at Selfoss in South Iceland**

*Note:* The building withstood peak ground acceleration equal to approximately 18% g on 21 June 2000. The strength demand is assessed to roughly 50% g. Distance from the building to the causative fault was about 14 km. No significant damage to the building was reported.

The older school buildings in Iceland are commonly low-rise simple structures, built either of timber or concrete. Such buildings have proven to be seismically robust due to their high specific strength. Modern school buildings are characterised by elegance and functionality obtained through new materials and new building forms, leading to increasing complexity compared with the older buildings (see Figure 2).

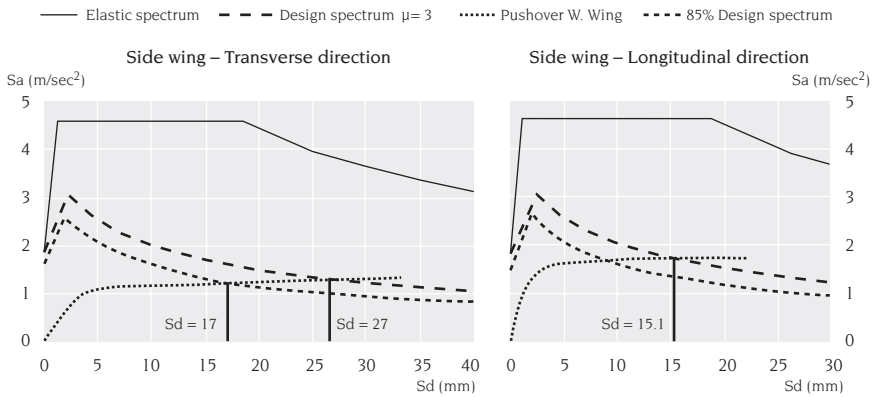
Figure 10. ADRS format capacity demand spectrum

The evaluation of the pushover analysis and the determination of the target displacement were based on the Acceleration – Displacement Capacity – Demand (ADRS) spectrum procedure prescribed by ATC-40.<sup>2</sup> The inelastic spectra have been derived by applying the formulas of Fajfar<sup>3</sup> on the Elastic Acceleration Spectra of the Greek Seismic Code for zone II.<sup>4</sup>

From these (Figure 10) it is obvious for both directions that the building can withstand the design earthquake, but only by consuming most of its inelastic capacity. This means that in both directions the building would sustain serious but not critical damage under the design earthquake. So the pushover analysis completely validated the results of the elastic dynamic analysis and indicated moderate intervention.
